Inspection Report

Report No.: XYSK-140505
 Supplier : XY-GLOBAL

Inspection only for: PO . XYSK-140505 Item No. XY11WD010	Inspection Result: PASS
---	-----------------------------------

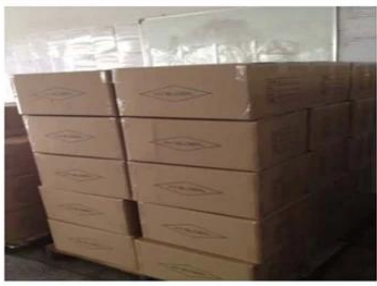
1. Packing	2. Product

Appearance Inspection : No failure,
Dimension Inspection: No failure , below measurement report for reference.
Assembly Test: No failure
Inspection Summary The inspection sample plan is 100% inspection.
