Inspection Report

Report No.: XYS-130907
Supplier : XY-GLOBAL

Inspection Date: 4th Oct, 2013
Inspector: Leo

Inspection only for: PO . XYS-130907 Item No.100097	<u>Inspection Result:</u> PASS
--	-----------------------------------

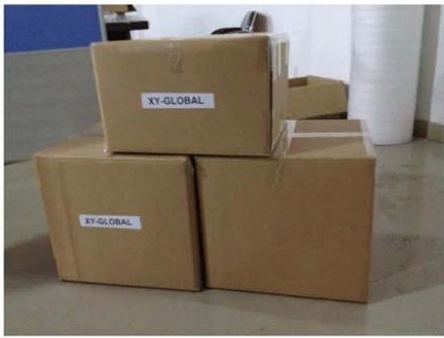
1. Packing	2. Product

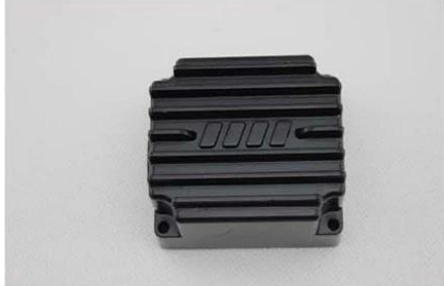
3. Product	4 Product

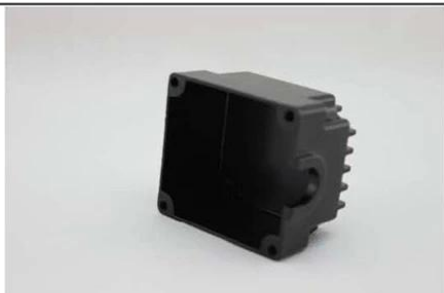
5. Product:	6. Product:
