Inspection Report

Report No.: XYS-130907
Supplier : XY-GLOBAL

Inspection Date: 4th Oct, 2013
Inspector: Leo

Inspection only for: PO . XYS-130907 Item No.100097	Inspection Result: PASS
--	-----------------------------------

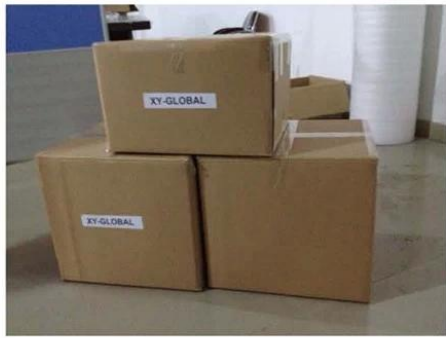
1. Packing	2. Product

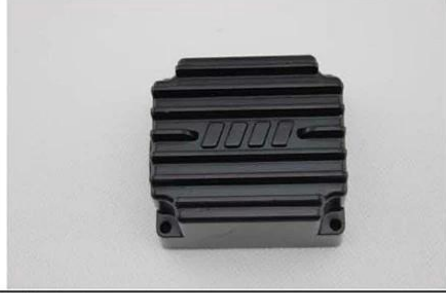
3. Product	4 Product

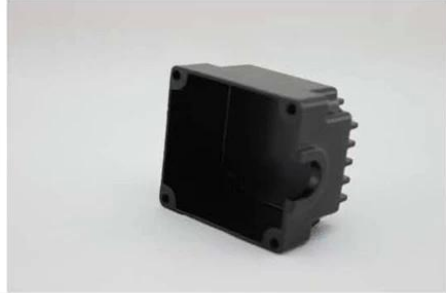
5. Product:	6. Product:
