**Inspection Report**

**Report No.:** XYS-130914  
**Supplier :** XY-GLOBAL

| Inspection only for:<br>PO . XYS-130920 Item No.3567200 | <b>Inspection Result:</b><br>PASS |

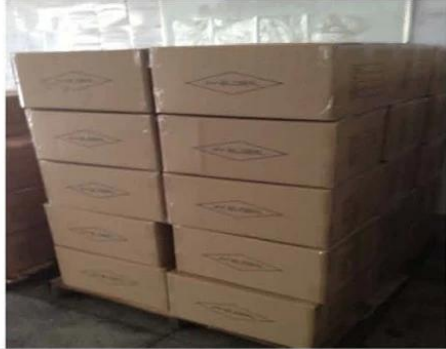
| 1. Packing | 2. Product |
