Inspection Report

Report No.: XYL-150720
 Supplier : XY-GLOBAL

Inspection only for: PO . XYL-150720 Item No. XY11LM020	Inspection Result: PASS
--	-----------------------------------

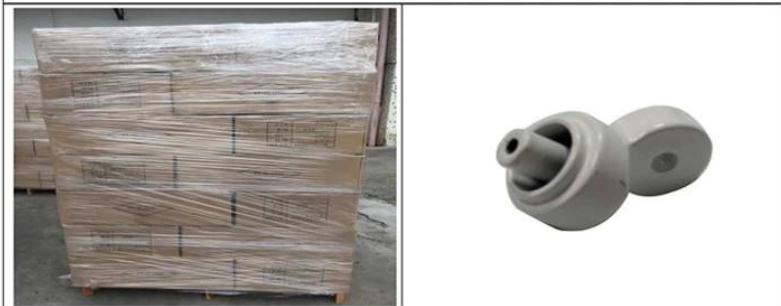
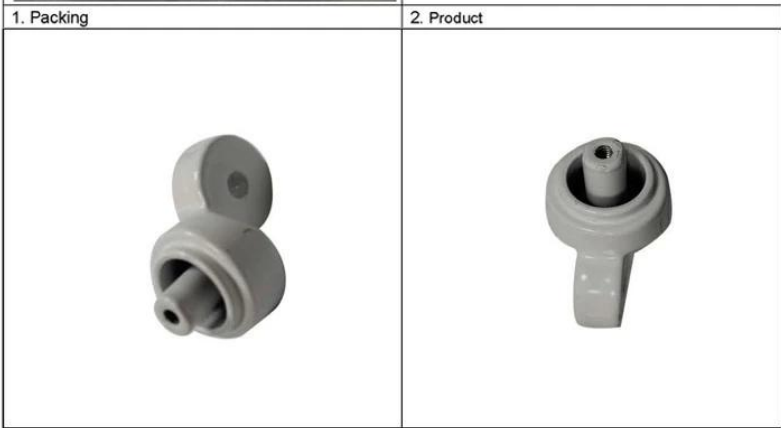
Appearance Inspection : No failure.
Dimension Inspection: No failure , below measurement report for reference.
Assembly Test: No failure
Inspection Summary The inspection sample plan is 100% inspection.
