Inspection Report

Report No.: XYL-150724
 Supplier : XY-GLOBAL

Inspection only for: PO . XYL-150724 Item No. XY11LM024	Inspection Result: PASS
------------------------------------------------------------	-----------------------------------

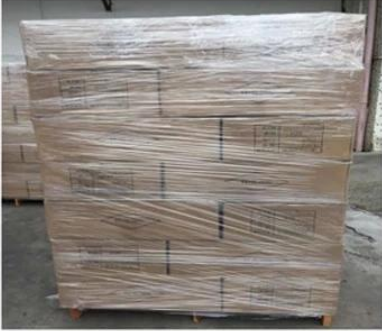
1. Packing	2. Product

Appearance Inspection : No failure,
Dimension Inspection: No failure , below measurement report for reference.
Assembly Test: No failure
Inspection Summary The inspection sample plan is 100% inspection.
